REPORT

Read All About It

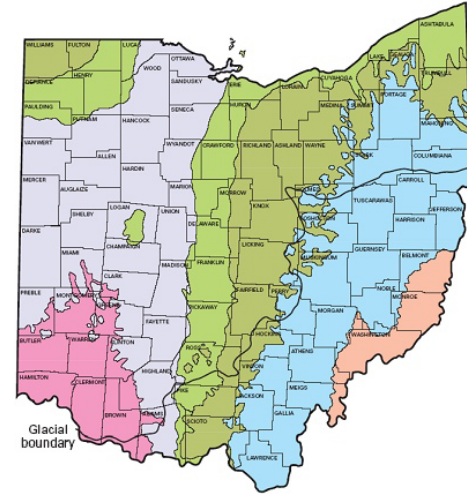
Graphic: The Ohio Geological Survey

As noted by the Ohio Department of Natural Resources (ODNR) on their web site (<http://www.dnr.state.oh.us>), the new “Bedrock Geologic Map of Ohio” shows the distribution of bedrock formations that are at the surface or just under the glacial deposits that often cover the bedrock (<http://ohiodnr.com/news/sep06/0920bedrockmap/tabid/15039/Default.aspx>). This new map replaces the previous version, which dates back to 1920.
